CONTINENTAL GRAFIX USA, INC. FIRE TEST REPORT

SCOPE OF WORK ASTM E84 TESTING ON NATUREWALK

REPORT NUMBER 105394591SAT-001

ISSUE DATE April 13, 2023

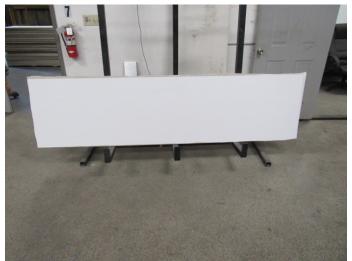
Photo No. 1 Exposed Surface of the Test Specimen (Pre-test)

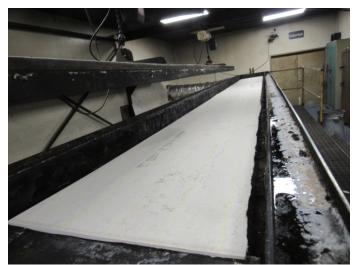
Photo No. 2 Unexposed Surface of the Test Specimen (Pre-test)

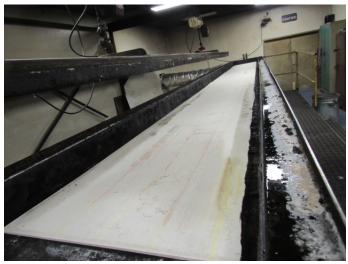
Photo No. 3 Unexposed Surface of the Test Specimen (Post-test)

TEST OBSERVATIONS		
Ignition Time	0:08 Minutes: Seconds	
Melting/Flaming Drops/Floor Flames	0:12 Minutes: Seconds	
Observations After the Test:		
0 – 9 ft.	Consumed	
9 – 24 ft.	Discolored

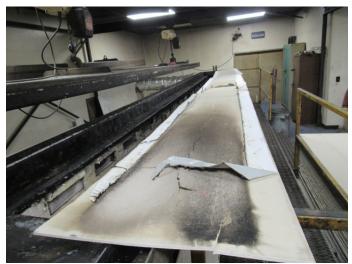
Photo No. 4 Exposed Surface of the Test Specimen (Post-test)
